# Spray Foam Insulation Condition Assessment

14 Birchwood Avenue, Coventry, CV3 5RJ

| Report Reference | SFC-2026-0116-CV3 |

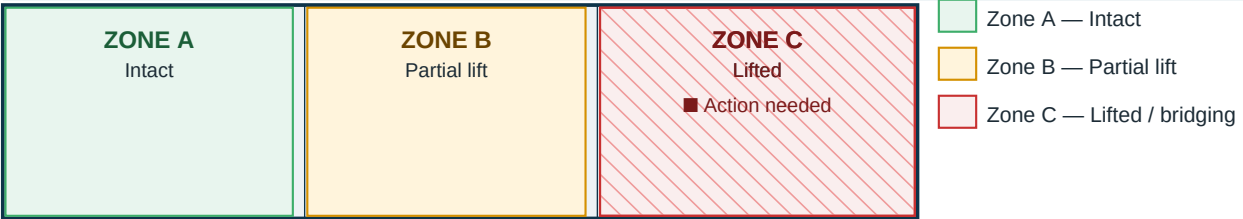
SPRAY FOAM CONDITION — ZONE PLAN (SCHEMATIC)

| ZONE | LOCATION | FOAM CONDITION | INDICATIVE MC |
|---|---|---|---|
| A | Front pitch Accessible | Intact — adhered to rafters No visible lift or separation | 14 – 18% Within range |

| ZONE | LOCATION | FOAM CONDITION | INDICATIVE MC |
|---|---|---|---|
| <b>B</b> | <i>Rear pitch Partially accessible</i> | Partial edge lift noted Minor separation at eaves | <i>22 – 31% Above equilibrium</i> |
| <b>C</b> | <i>Hip end Accessible</i> | Significant lift and bridging<br>Rafter masking observed<br>Moisture trap indicators | <i>34 – &gt;45% Instrument maximum</i> |

Zone A presents no immediate cause for concern at time of inspection. Zone B warrants monitoring. Zone C presents significant concerns requiring specialist further investigation prior to any remediation works being specified or instructed.

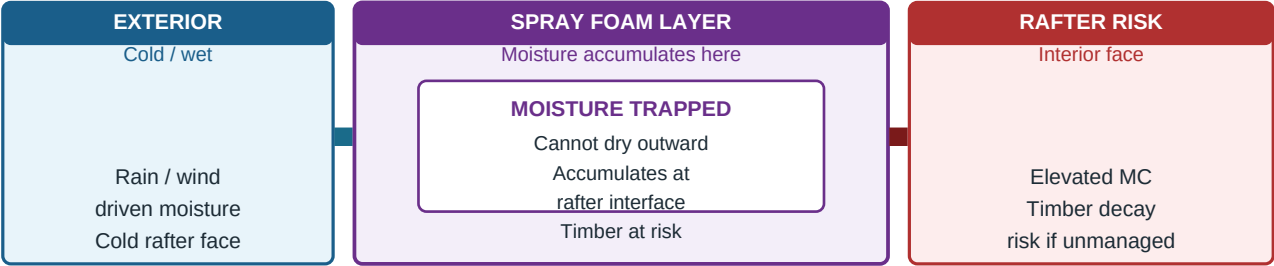
MOISTURE TRAPPING MECHANISM — SPRAY FOAM ON RAFTERS

Schematic — not to scale. Advisory representation of moisture trapping risk mechanism. Based on observed conditions.

Readings in Zone C exceeded the calibrated maximum measurable threshold of the instrument (>45%) at two measurement points. This is recorded precisely as ">45% (Instrument Maximum)". These readings indicate moisture content beyond the instrument display capacity and are consistent with active moisture accumulation at the rafter/foam interface.
